# Water is Life: Mapping Water Access in Peri-urban Malawi

**Student research team, led by Dr. Emily Van Houweling**

# Site Description

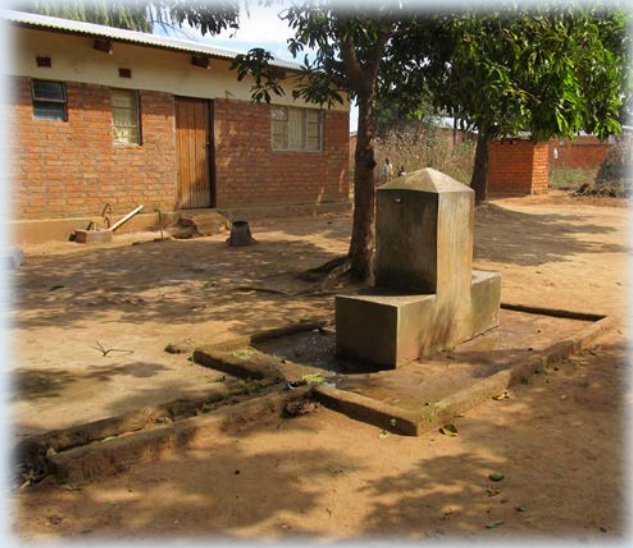
Community Tap: 10% of surveyed households use

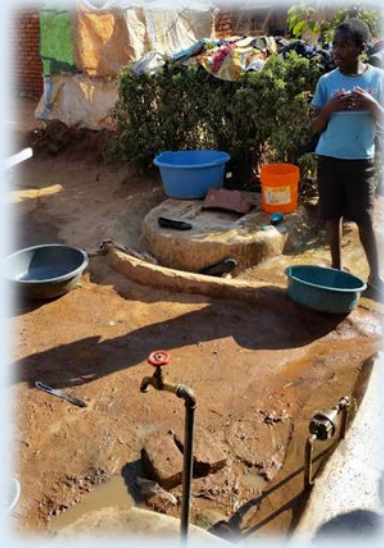
Private Tap: 61% of surveyed households use

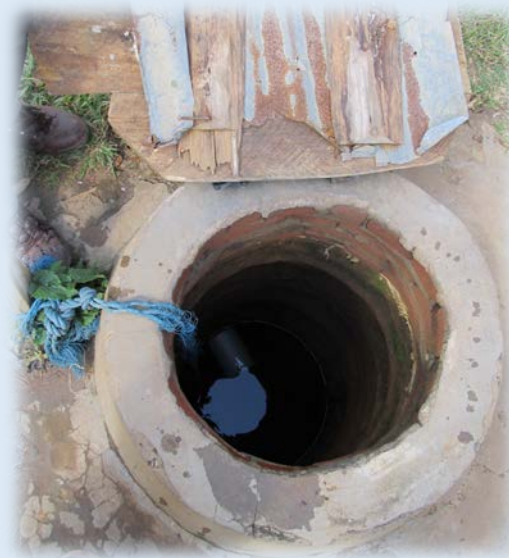
Partially Covered Well: 43% of surveyed households use

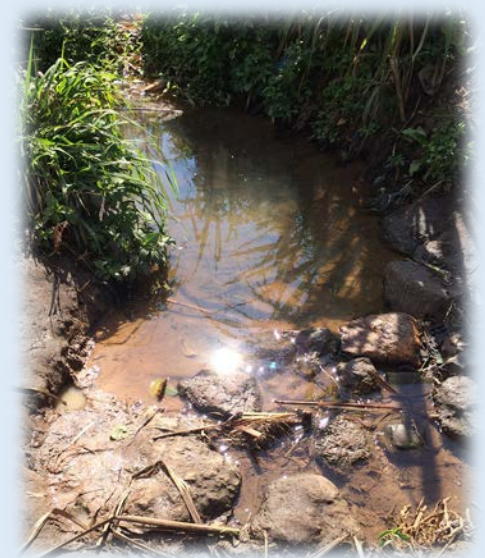
Unprotected Source: 0.6% of surveyed households use

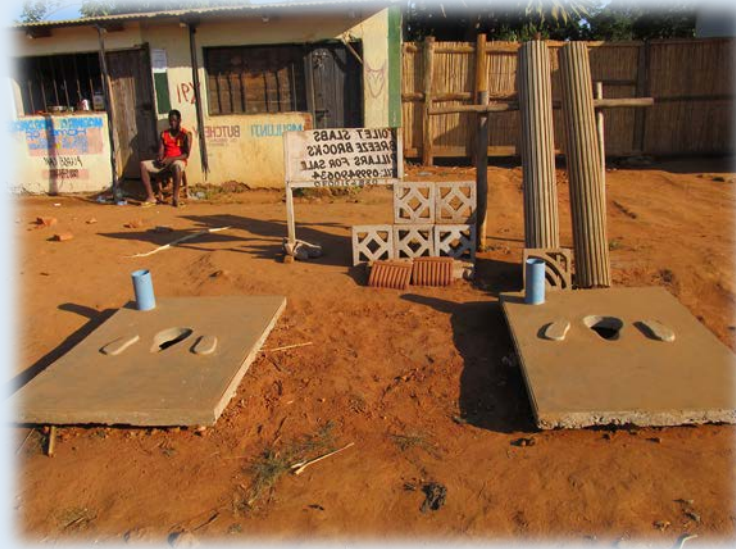
Latrine slabs for sale in local market

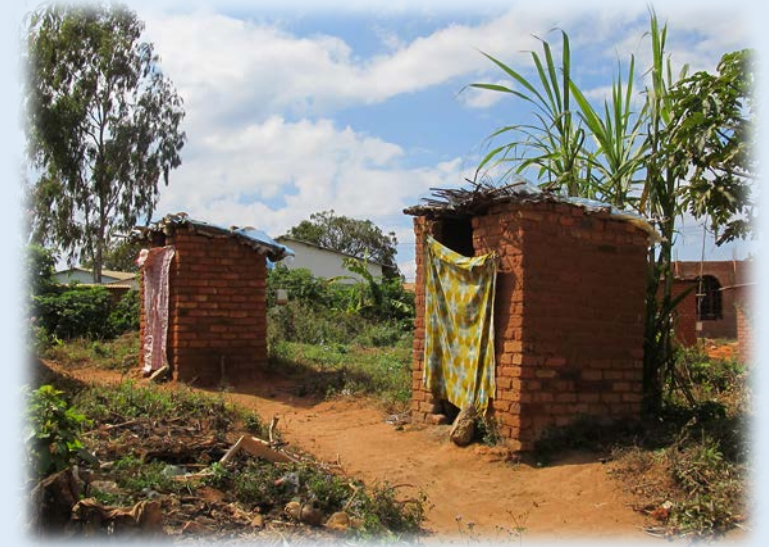
Shared Pit Latrines: 56% of surveyed households share pit latrines

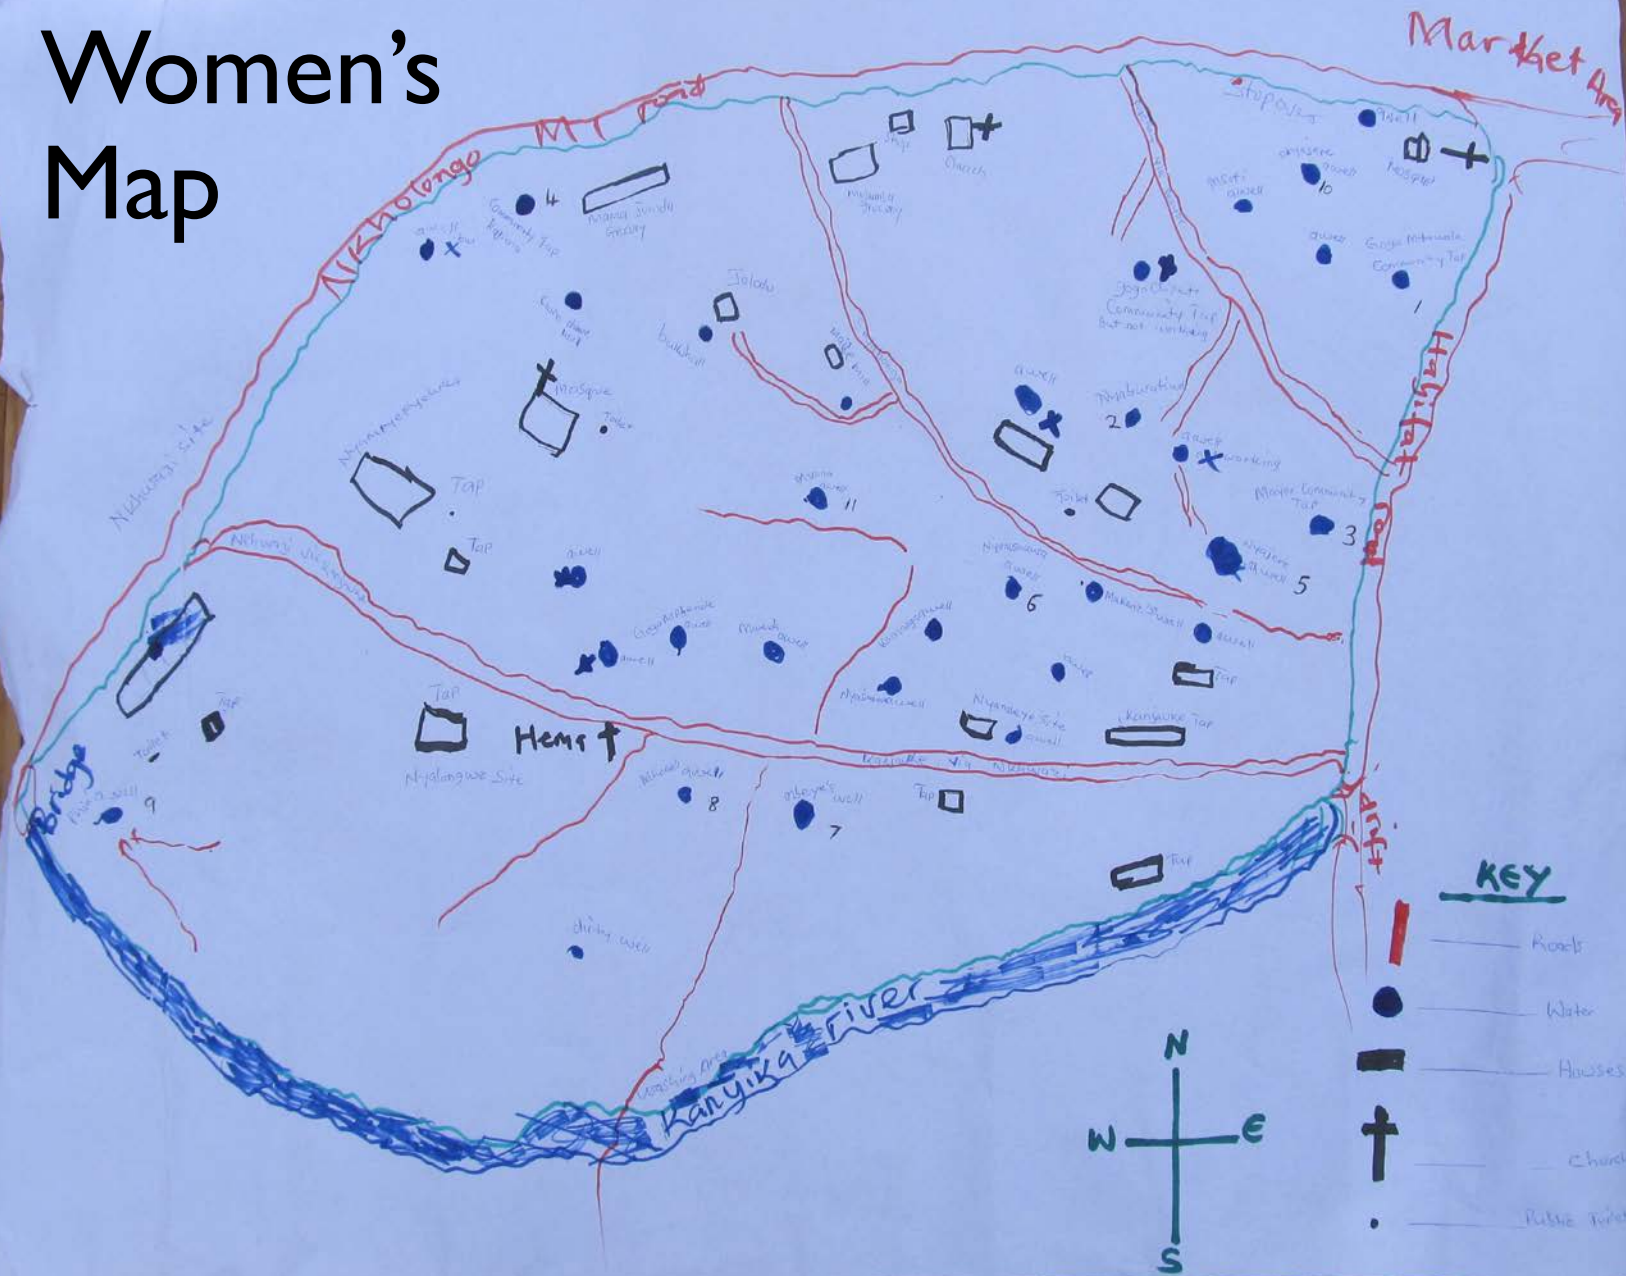
# Women's Map

- 31 hand dug wells, 4 non-operational
- 3 operational communal taps, 1 non-operational communal tap
- Drew the church, mosque, and the mill
- Indicated more dug wells

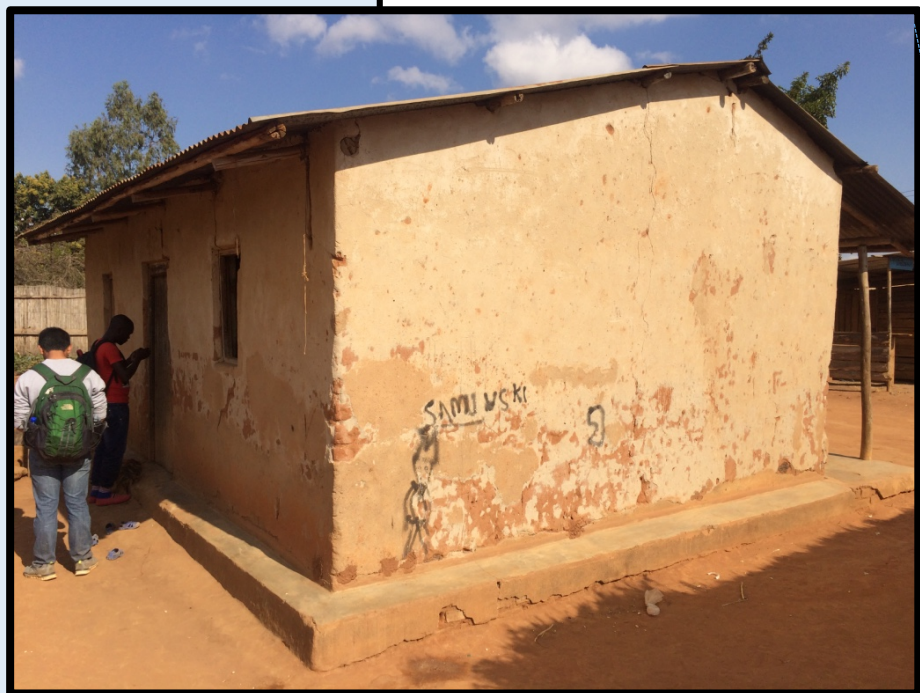
# Households cont.

HOUSINGATTRIBUTES

Location: 609,203.702 8,739,162.724 Meters

Field	Value
FID	140
Shape	Point
Mapping_Co	H70
ele	1308.22998
House_Numb	20
Water_Sour	Well
Water_So_1	1
Latrine_Ty	Pit Latrine
Latrine_Sh	1
HHs_Using	2
Owner_of_h	0
Roof_Type	0
Electrical	0
Other_Poin	
Road_Name1	
Road_Name2	
Notes	Latrine does not have thatched roof
F18	
EASTINGS	609203.683476
NORTHINGS	8739162.70295
